4. TITLE (and Subtitle) Phase I Inspection Report National Dam Safety Program. Stony Brook Watershed Dam Site 7 (NJ00344), Mercer County, New Jersey, Raritan River Basin, Stony Brook, Mercer County, New Jersey. Phase I Inspection Report.		5. TYPE OF REPORT & PERIOD COVERED (9) FINAL rept. 7

6. PERFORMING ORGANIZATION NAME AND ADDRESS Storch Engineering 220 Ridgedale Ave. Florham Park, N.J. 07932		7. CONTRACT OR GRANT NUMBER(s) DACW61-79-C-0011

OVERVIEW - STONY BROOK WATERSHED SITE NO. 7 DAM

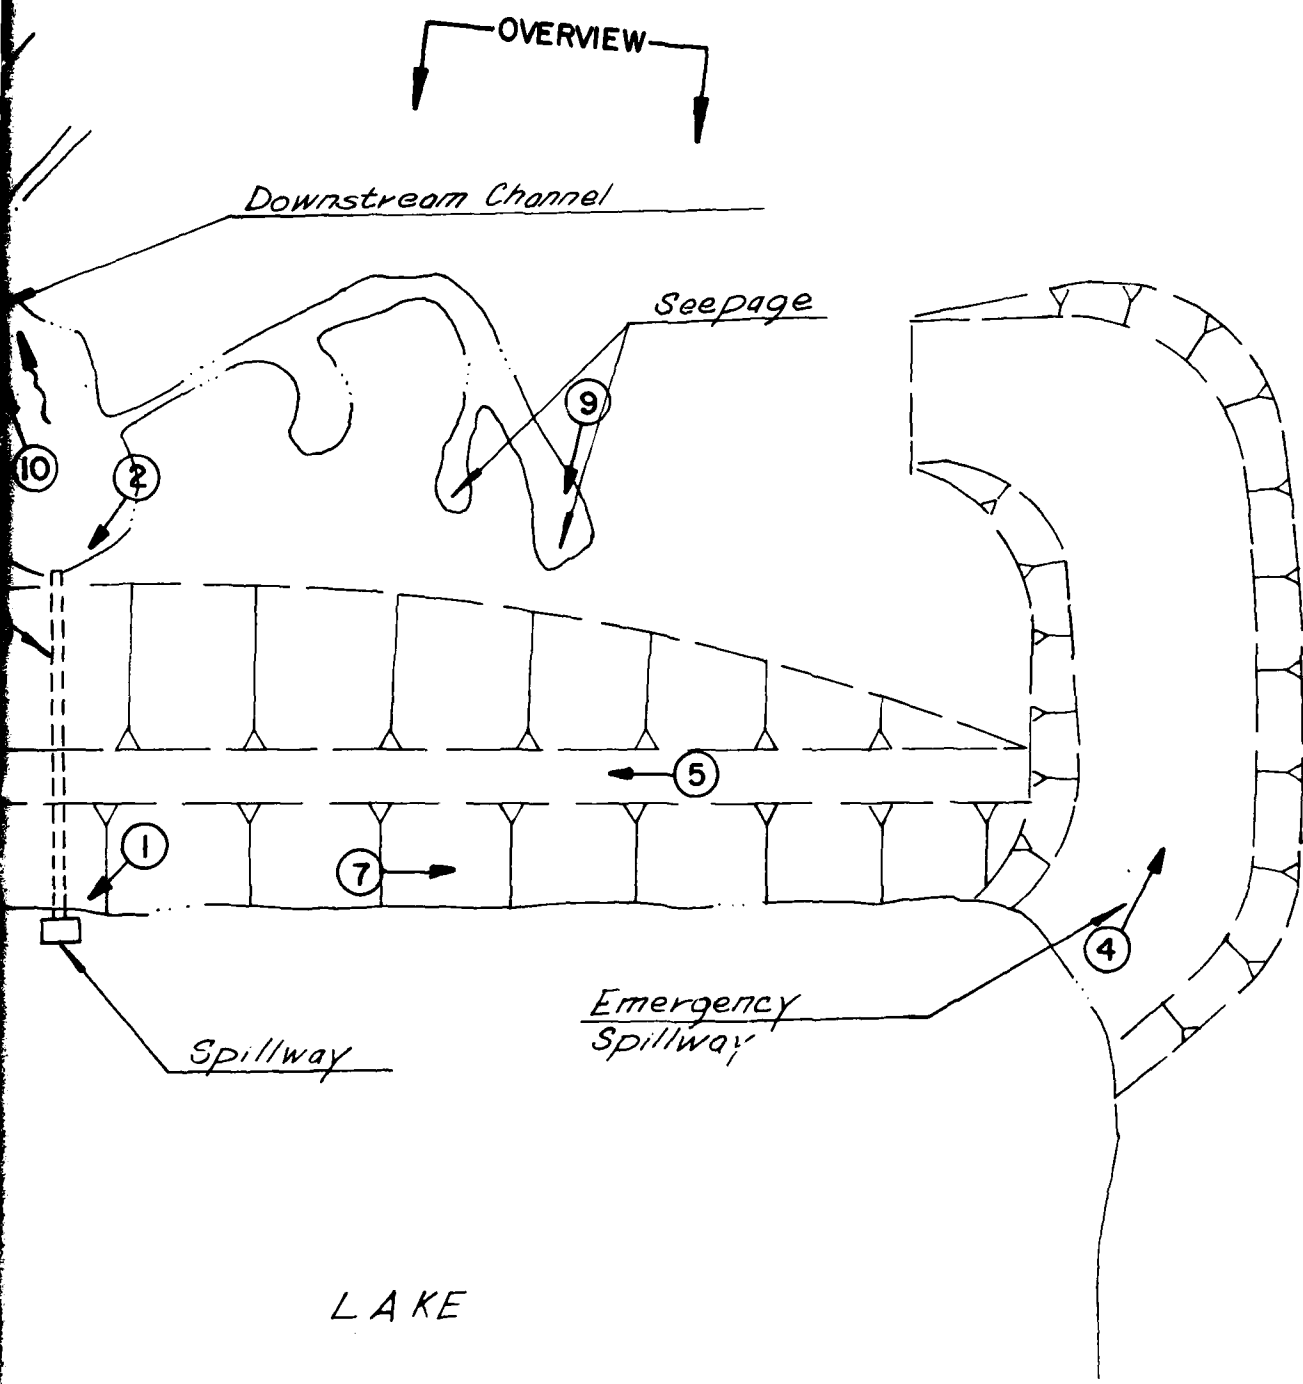
PLATE 7

STORCH ENGINEERS FLORHAM PARK, NEW JERSEY	DIVISION OF WATER RESOURCES N.J. DEPT. OF ENVIR. PROTECTION TRENTON, NEW JERSEY
INSPECTION AND EVALUATION OF DAMS PHOTO LOCATION PLAN STONY BROOK WATERSHED SITE NO. 7 DAM	
I.D. N.J. 00344	SCALE: NOT TO SCALE DATE: DEC. 1979
